Appendix B. Escape report

Place: San Juan de la Costa – off shore site

Date: December 6 of 2018

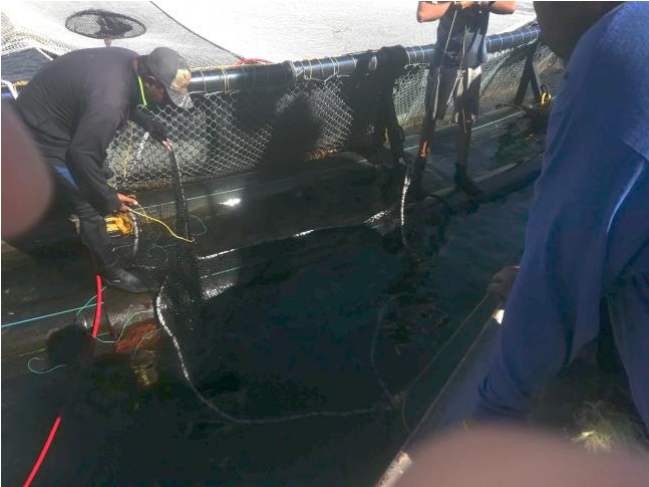
1. On Wednesday 19 and Thursday 20 there was a storm with winds of 20 Kt.
2. The gate of cage 3 has surplus metal cable on the edges, this cable got hooked with nylon net during the storm consequence of the waves.
3. This produced a breaking of 15 to 20 cm in the nylon net, which was found during the routine post-storm mesh review on Friday 21.
4. Due to the breakage there was an escape of approximately 1500 fish.
5. The fish have stayed near the cage perimeter and we have been able to recover approx. 700 units and we continue to recover every day. The fish that cannot be recovered will be fed between Nylon and copper net until they reach the size that the copper net will contain them.

<p><u>Image</u></p>
<p><u>Fish recapture.</u></p>	<p><u>Description</u></p>
<p><u>Image</u></p>	<p><u>Image</u></p>
<p><u>Description</u></p>	<p><u>Description</u></p>

1. Install spiral pieces of copper material in each risk area
2. Install protective net strip to avoid contact between Copper and Nylon material.
3. A third option is to install double nylon net, but this will in consequence double the amount of fouling and it is difficult to connect to the cage.
